RESEARCH ARTICLE	State of Conservation of the Kef Lemssaour Rock engraving walls (Souk Ahras, Algeria)
Mansouri Farida	Maitre de conférences -A
	Institut d'archéologie Université Alger2
	Algeria
	Email: farida.mansouri@univ-alger2.dz
Doi Serial	https://doi.org/10.56334/sci/8.5.73
Keywords	Kef Lemssaour, Rock art walls, State of conservation, Rock engraving walls
Abstract	
Rock art is considered one of the largest and most important artistic manifestations witnessed by humanity in prehistoric times. It reflects the extent of human interest since ancient times in art to embody various aspects of daily and social life, as well as religious beliefs. These beliefs were expressed in a precise manner, using drawing, sculpture, or engraving on stones in shelters, caves, and grottoes. Given the importance of rock art, we conducted research on a sample of it, specifically rock engravings. We chose the Kef Lemssaouar site because it is threatened with extinction, and studying it contributes to enriching the historical information of one of the most significant areas in eastern Algeria, which provides information that was previously known only in desert regions.

1- Glimpse of the Rock engravi

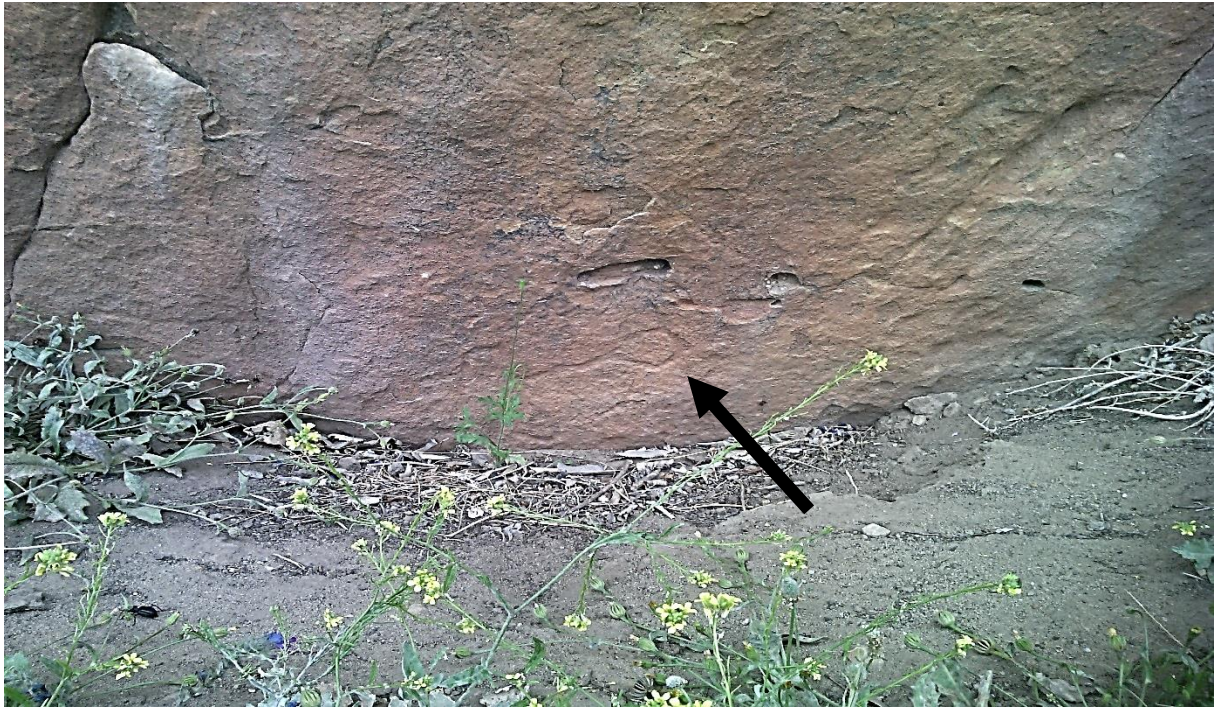
Fig.6: The possible engraving of the antelope (the second part of the third mural).

It is located east of the second mural, 10 meters away, and is divided into two sections. The first section features an engraving of a ram and a figure that appears to be a shepherd (Gillette & Lefebvre L., 1967, p.221) (Fig.5-6). The second section contains an engraving that is likely of an antelope (Antilopinae) in a running position, indicating that it is either in a breeding season or during mating, according to some specialists. This is the only engraving that has not been addressed by any previous researchers, neither in terms of drawing nor analysis, possibly due to it not being noticed earlier, as it only became visible after erosion factors.
